## Implementation of an Erosion Control Program to Reduce Sediment Loading Rates from Land-Based Sources to the Coral Reefs of Culebra, Puerto Rico

Punta del Viento Estates Development Area

**August 2012**

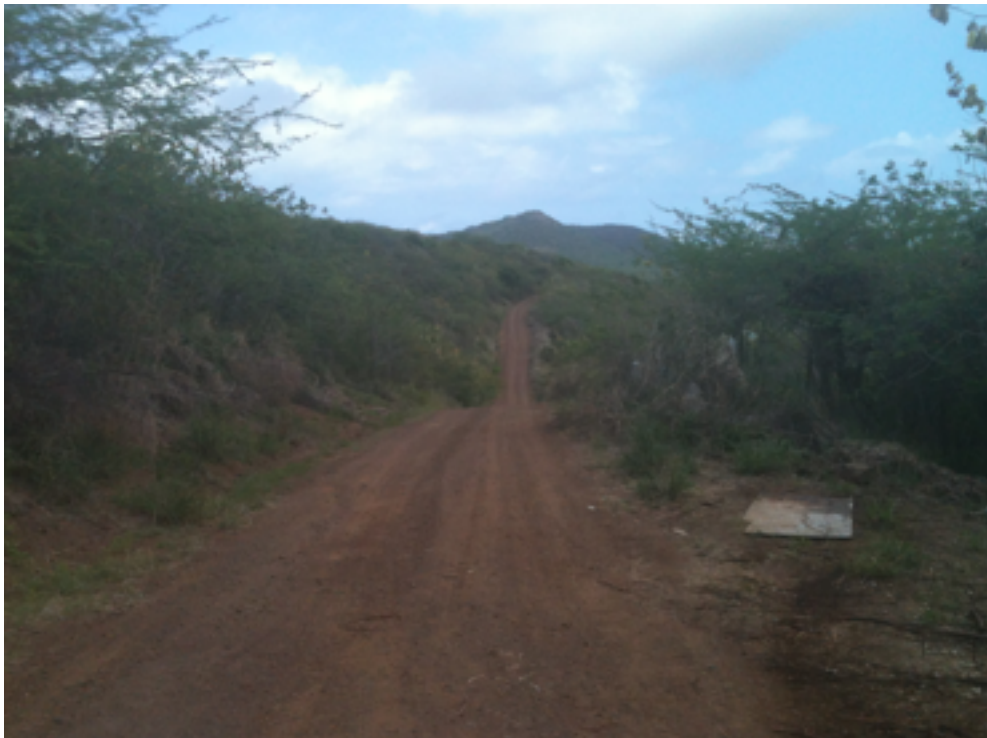
Figure 1. Illustrates one of the road areas for stabilization in Punta del Viento

Approximately one half mile of road was stabilized with a number of practices including approximately 30 rock check dams, 5 inlet and outlet protection, 3 cross swales to convey water in small amount to native vegetation areas where water could be infiltrated and uptaken by plants. The main goal was really to distribute the runoff into as small as units as possible -- so it would have minimal time to pick up additional sediment, and so it could be effectively managed by natural vegetation and soils.

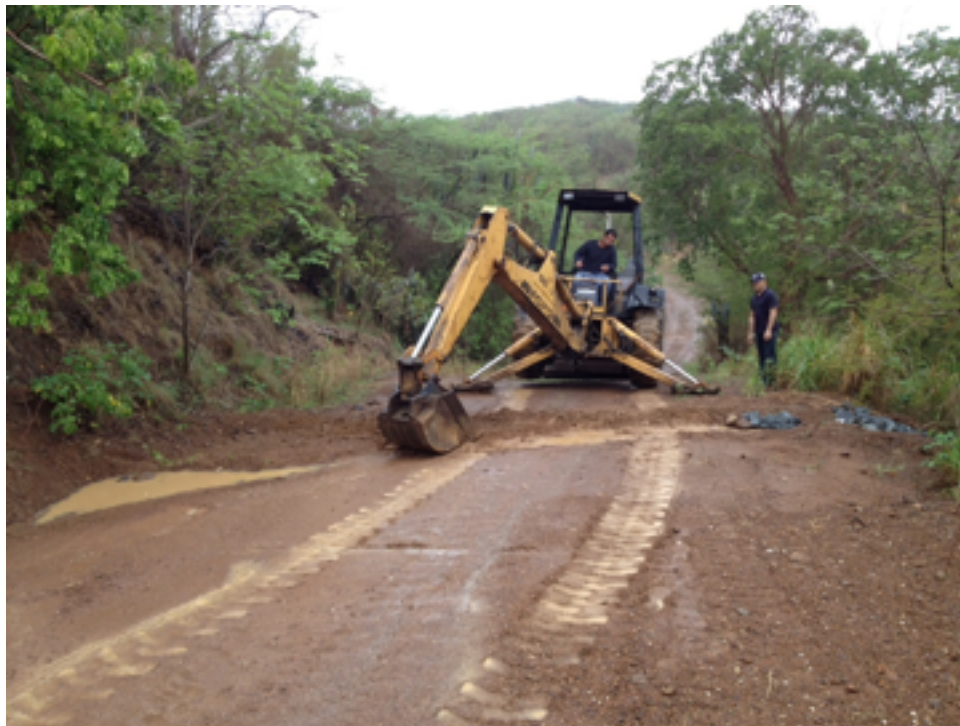
Figure 3. Illustrates the construction of a cross swale and outlet protection

The main practices installed were cross swales (Figure 3), rock check dams (Figure 6) and rock outlet protection (Figure 3). Cross swales were used to distribute the flow into smaller units before return to vegetation; rock check dams were used to slow velocities; and rock outlet protection was used to limit erosion and head cutting at outfalls.

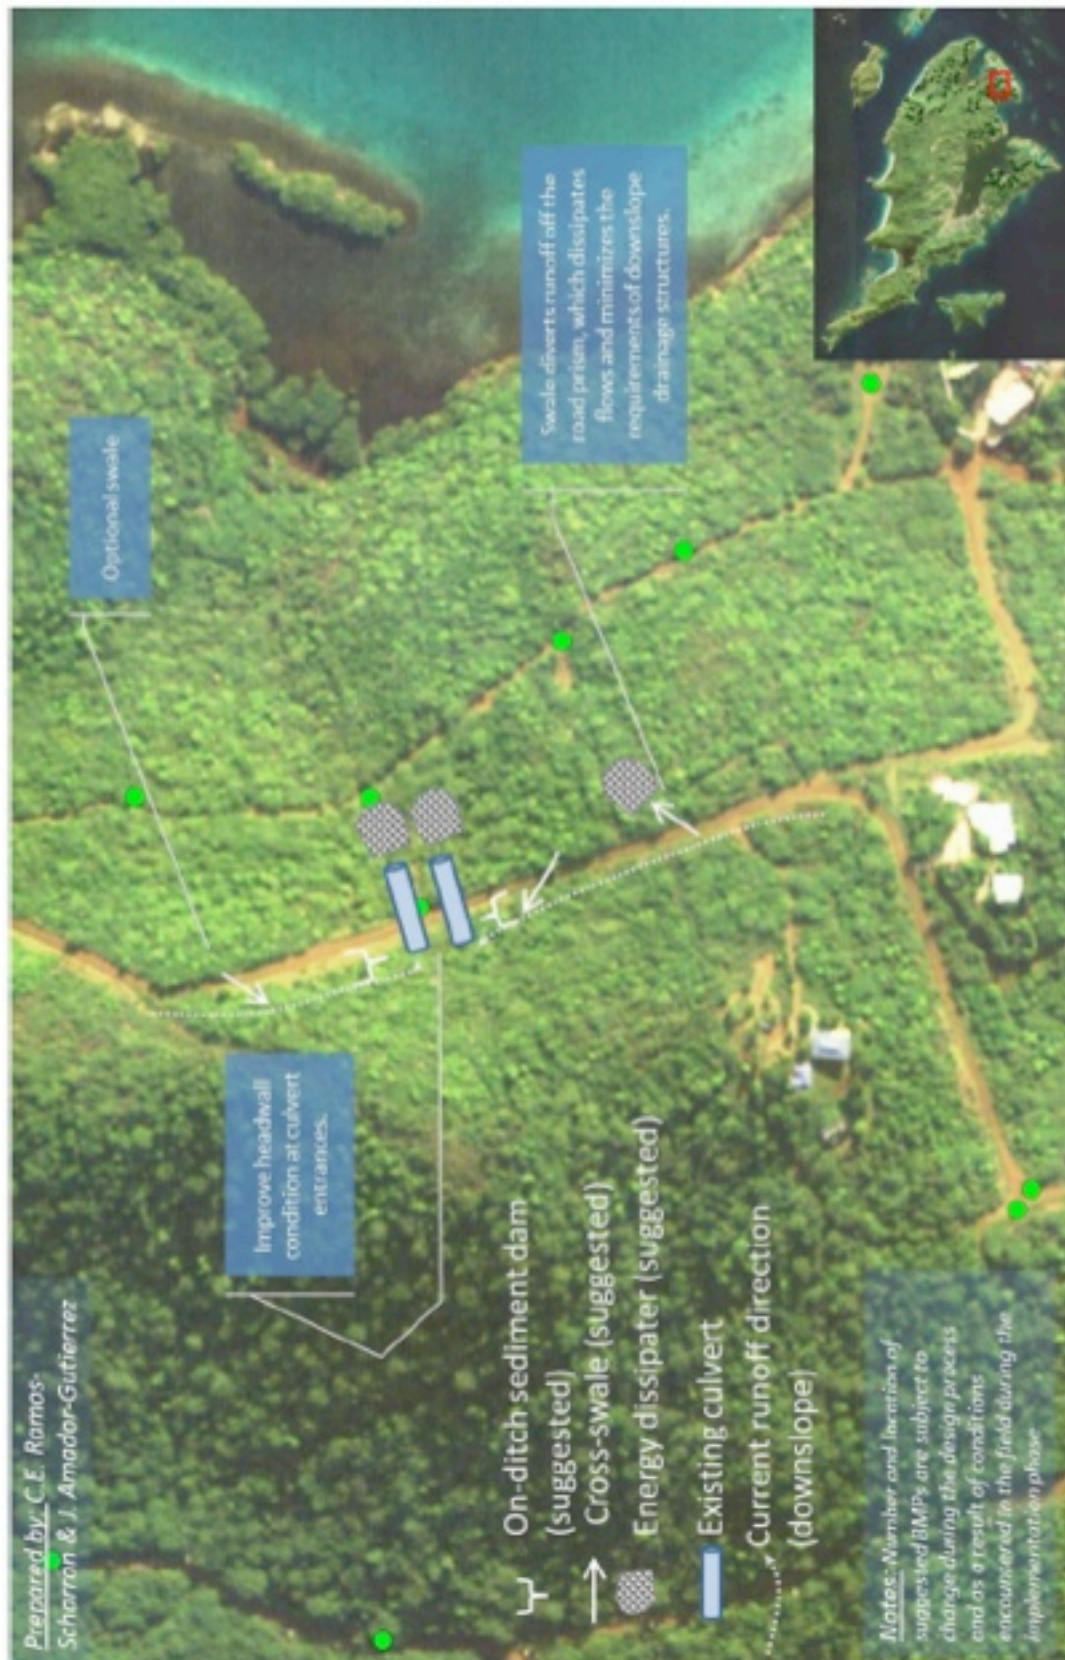
Figure 5. Restoration Site #2 and Proposed Practices

An overview of the work that was to be done is provided in Figure 4 and Figure 5. The main changes to the original design were adding additional check dams to reduce velocity in the drainage channels and the inability to create a cross swale across the road at Restoration Site #2 because of a shallow existing water line (additional check dams were used to reduce the velocity of water flow to compensate for the limitation. Eduardo and Juan, the on-site engineers with GMA COOP, organized the personnel on the four backhoes who were all working on various aspects of the erosion control practices at the same time and they completed the work quickly. Our limitation to accomplishing even more beyond the scope was the limited amount of rock we had for the check dams and outfall protection.

In the future some of the design work can be done as the stabilization is being completed as microtopography and utilities are not mapped by are in many cases only known by the operators themselves -- since they installed them. As a result in the field in our recent work, we had to change the designs due to the location of a water line in the middle of the road -- that limited any excavation on the road surface.

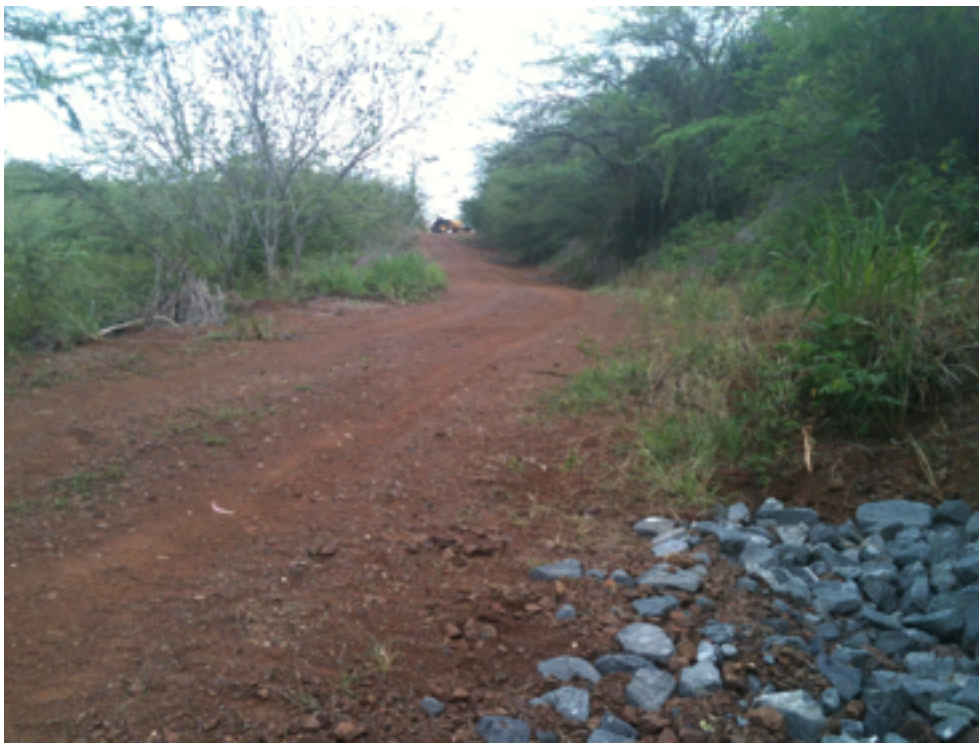
Figure 6. Note a series of check dams up the hill on the right (these slow the velocity of the water and drop out sediments) also the cross swale in Figure 3 was constructed midway up the hill to reduce the drainage area of the flowpath. The rocks in the foreground attenuate flows coming from the opposite direction.

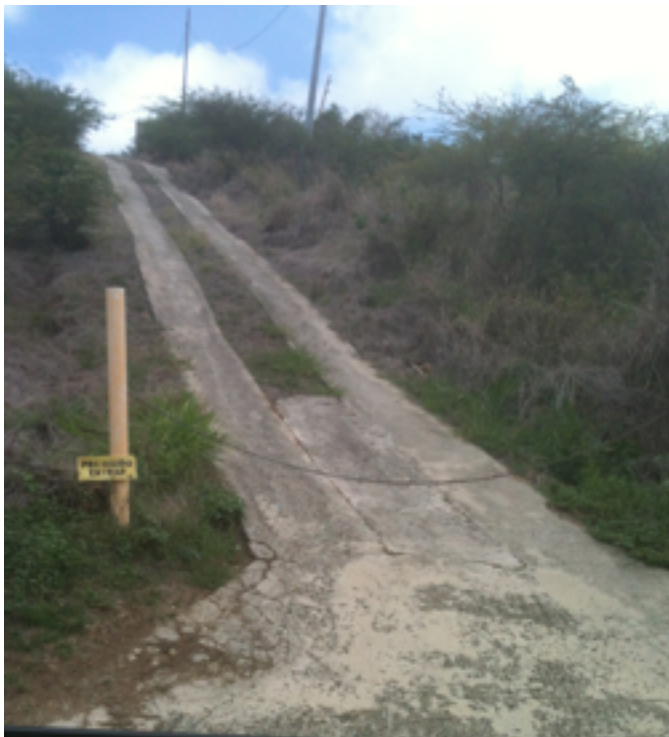
Figure 8. Example of a road on a steep slope that seemed to have minimal impact - two track drive - minimal impervious cover and crowned in the middle. This is a potential BMP for steep high use areas.
